RETROFITTING & RENOVATION
WORKS AT HOUSE OF HABIB
CONTRACTOR:

RE-BUILD CONSTRUCTION PVT. LTD

## UNILEVER HEAD OFFICE, AVARI TOWERS

RETROFITTING WORKS AT
UNILEVER HEAD OFFICE
CONTRACTOR:
RE-BUILD CONSTRUCTION PVT. LTD
CONSULTANT: MUSHTAQ & BILAL

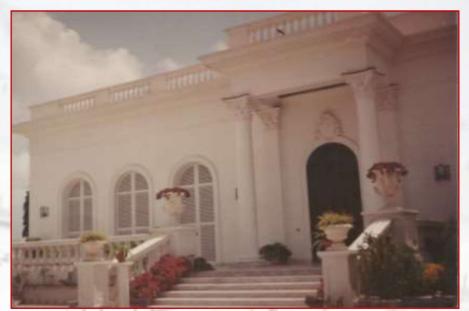
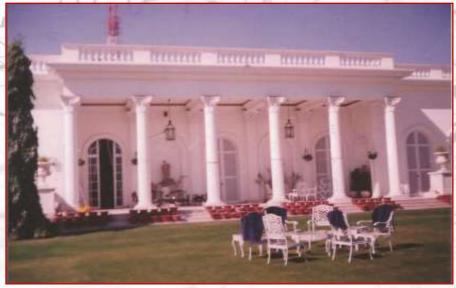
- > Resides at mountain tip of Muhammad Ali Society, Karachi.
- ➤ Since early 90s, renovation work is going on by our hands not just architecturally but structurally.
- > Due to movement of mountain it is common to have marble damage landscaping repairing work.
- ➤ RBC is continuously maintaining the flooring, walls, underground and overhand tanks, boundary walls.
- ➤ Fiber lining technique is used by RBC for repair of existing Water Tanks.
- ➤ One of the renowned name in Pakistan in many endeavors, House of Habib is a satisfied client of RBC.

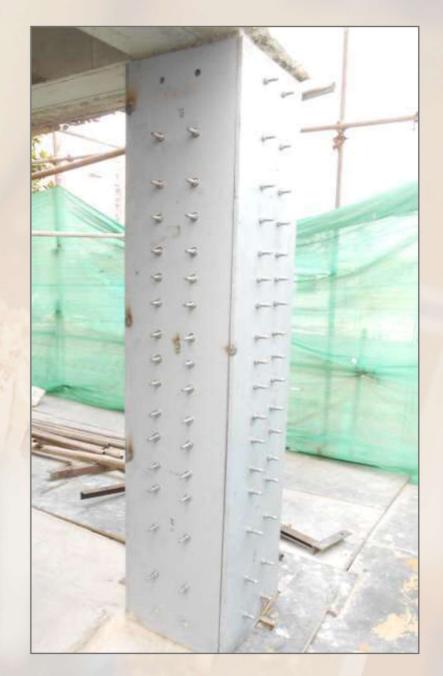
- ➤ Specialized Seismic Retrofitting was required at Unilever Head Office so RBC presented the most efficient work plan.
- ➤ Initially around 30,000 holes were required in existing structure for jacketing work.
- ➤ For drilling holes Ferro scanning was done along with preparation of as-built drawings for installation of anchors.
- > Based on our drawings MS Plates were prepared.
- About 40,000 chemical rebars and 16,000 anchors of M12, M16 and M20 were fixed.
- ➤ All the work was executed efficiently. Jacketing by MS Plates installed using chemical anchors with high precision and without damaging existing structure internal reinforcement

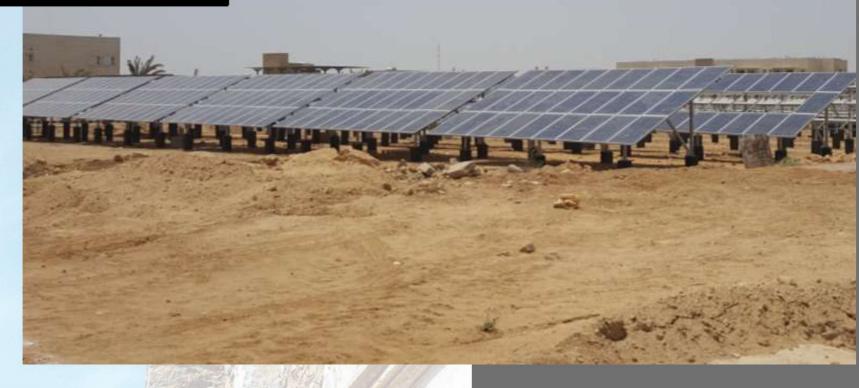
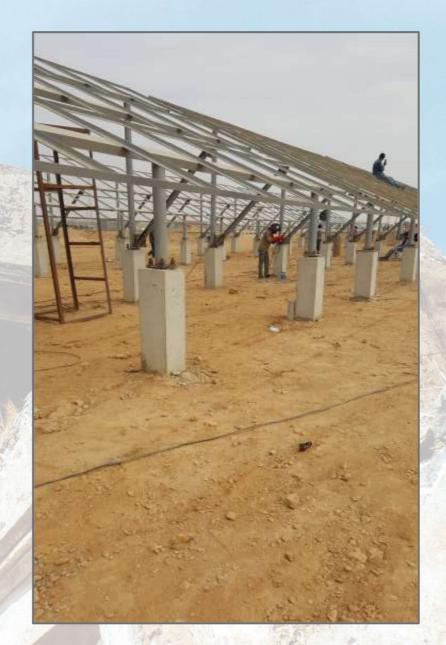
FIXING OF SOLAR PANELS IN HARD
STRATA
CONTRACTOR

- Solar panels were to be fixed by another contractor but during excavation rocky strata was found which made excavation very difficult job and the work could not be continued.
- Another approach was required for work execution so RBC provided the best work plan for execution of work which made the task easier and more efficient.
- ➤ Pull out tests were conducted and substrate was checked before drilling.
- > Design was based on the worst scenario considering minimum strength of substrate.
- Rebars were installed using Rawlplug® RKEX-II Epoxy in holes till 18" of depth.
- ➤ Then solar panels were fixed supported by pedestals. Hence the work was completed successfully.

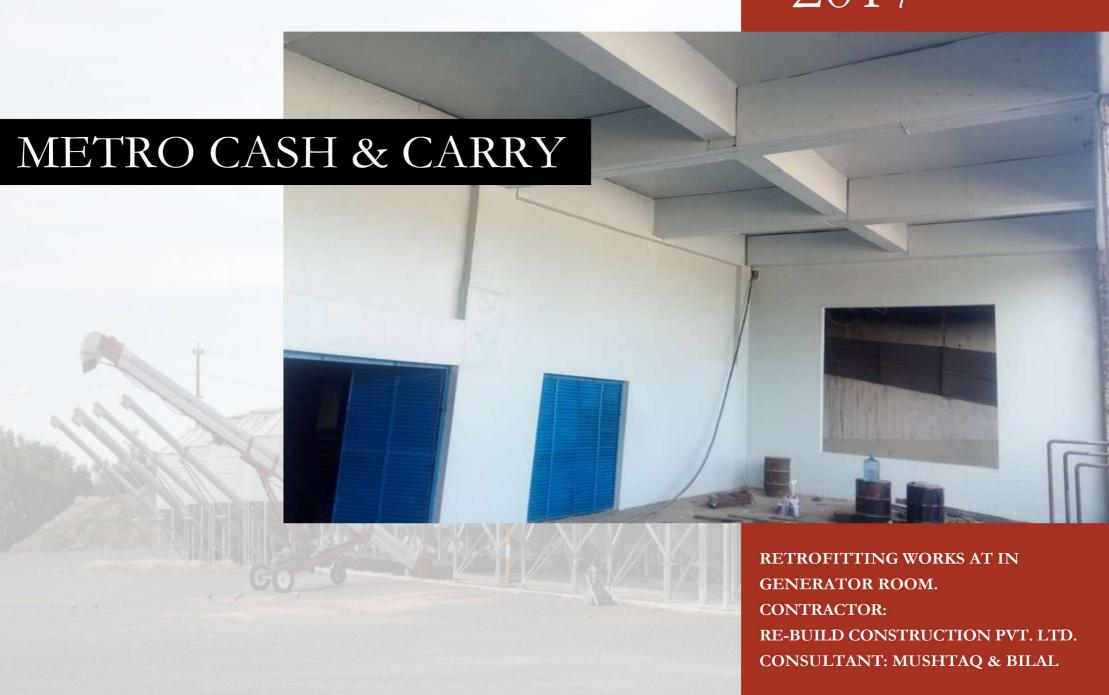
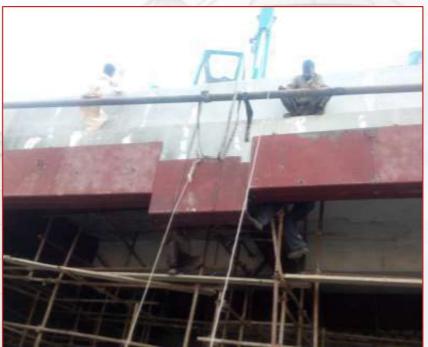
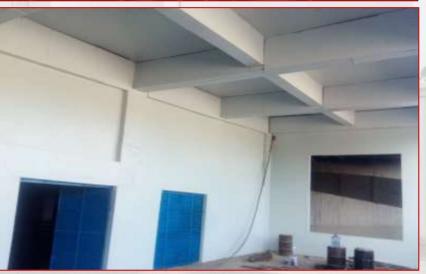
- ➤ Retrofitting was required at Metro generator view due to destruction caused by fire so RBC presented the most efficient work plan.
- Ferro scanning was done before drilling to avoid damage to internal reinforcement and to facilitate drilling of holes for anchors.
- > As-built drawings were also prepared.
- Slabs and beams were provided with MS Plates that were installed through chemical anchors. Lateral bracings were also fixed.
- > Anchors were placed in staggered pattern.
- > Jacketing of structural members was done efficiently.

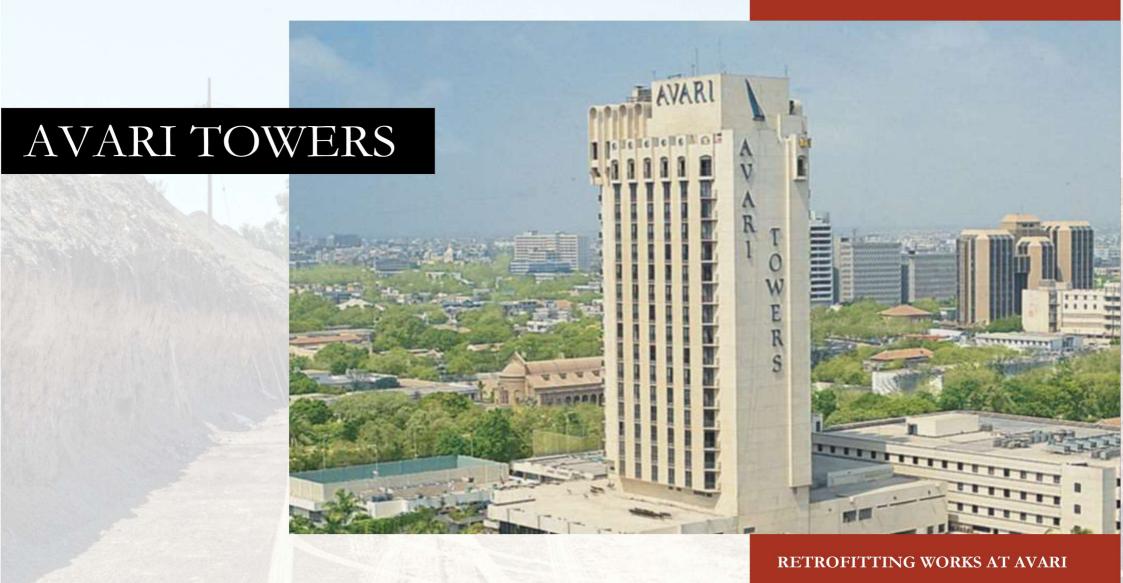
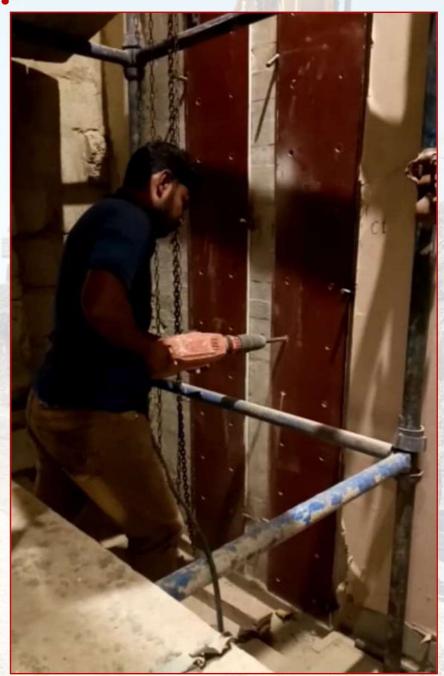
**TOWERS**

- > Specialized Seismic Retrofitting was required at Avari towers so RBC presented the most efficient work plan.
- > Complete structure analysis was conducted.
- ➤ Before drilling holes Ferro scanning was done along with preparation of as-built drawings for installation of anchors.
- > Based on our drawings MS Plates were prepared.
- MS Plates were installed using chemical anchors with high precision and without damaging existing structure internal reinforcement.
- About thousands of chemical rebars and anchors of M12, M16 and M20 were installed.
- > Pull out tests were conducted.
- > All the work was executed efficiently.

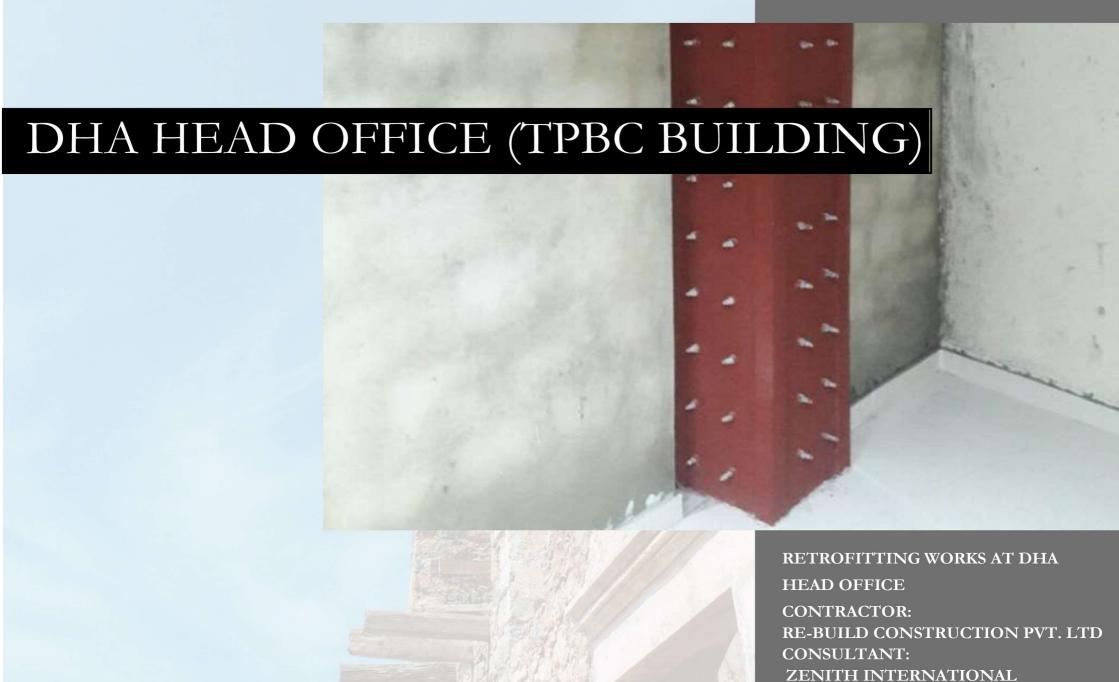
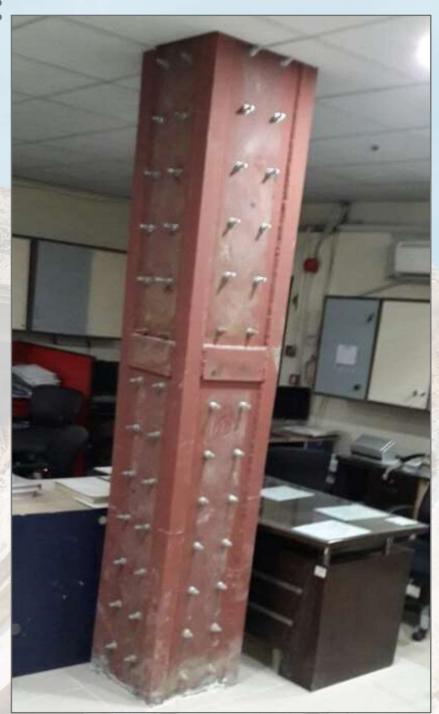
- ➤ Specialized Retrofitting was required at DHA Head Office so RBC presented the most coherent work plan.
- Schmidt hammer test was conducted to identify existing strength.
- Ferro scanning and As-built drawings were also prepared.
- > Pull out tests were also conducted.
- Excavation till bottom of footing was executed.
- Concrete was poured in foundations to increase their strength.
- Columns were Strengthen by Jacketing through MS Plates.
- MS Plates were installed through chemical anchors using high quality Epoxy.
- The Head Office was retrofitted and the whole task was executed efficiently.

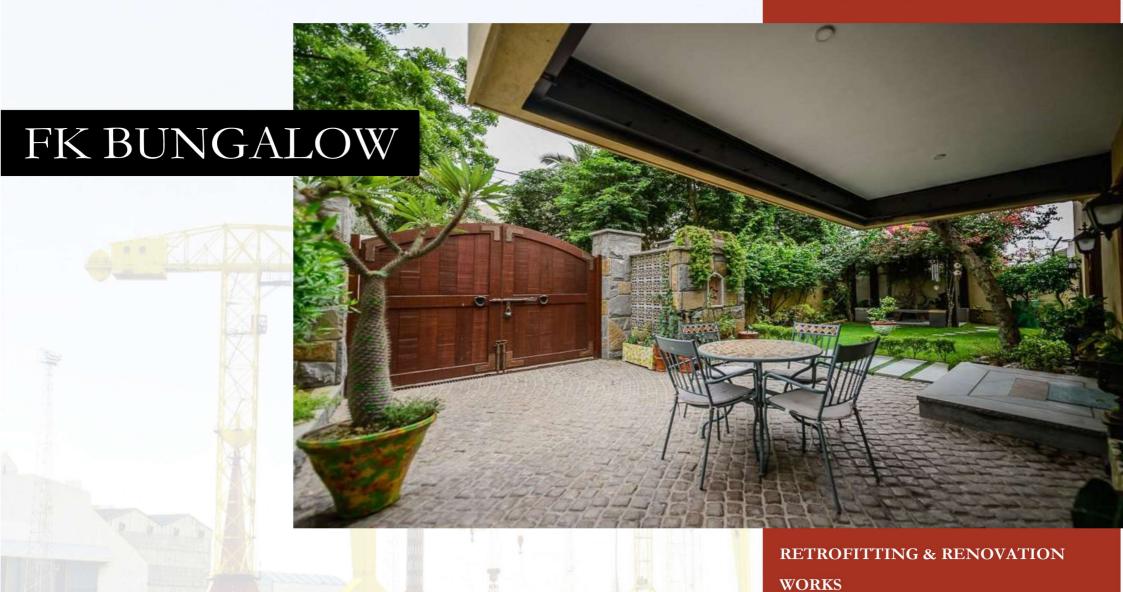
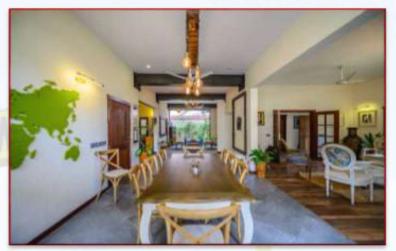
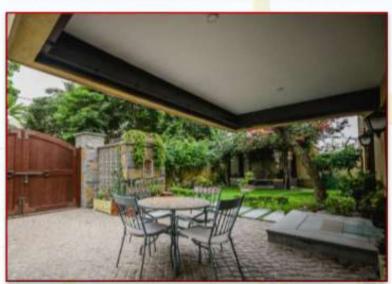
- > Retrofitting and renovation was required at Faraz Khan Bungalow.
- > Girders were fixed through anchors.
  These girders were later painted.
- All the irregular walls, beams and columns were flattened.
- > To control the cantilever action, steel sections were installed.
- Measures to control seepage and roof leakage were also taken.
- Layout of different rooms was reconfigured.
- All the necessary wiring, plumbing and ductwork was executed. After surface treatment the rooms were painted.

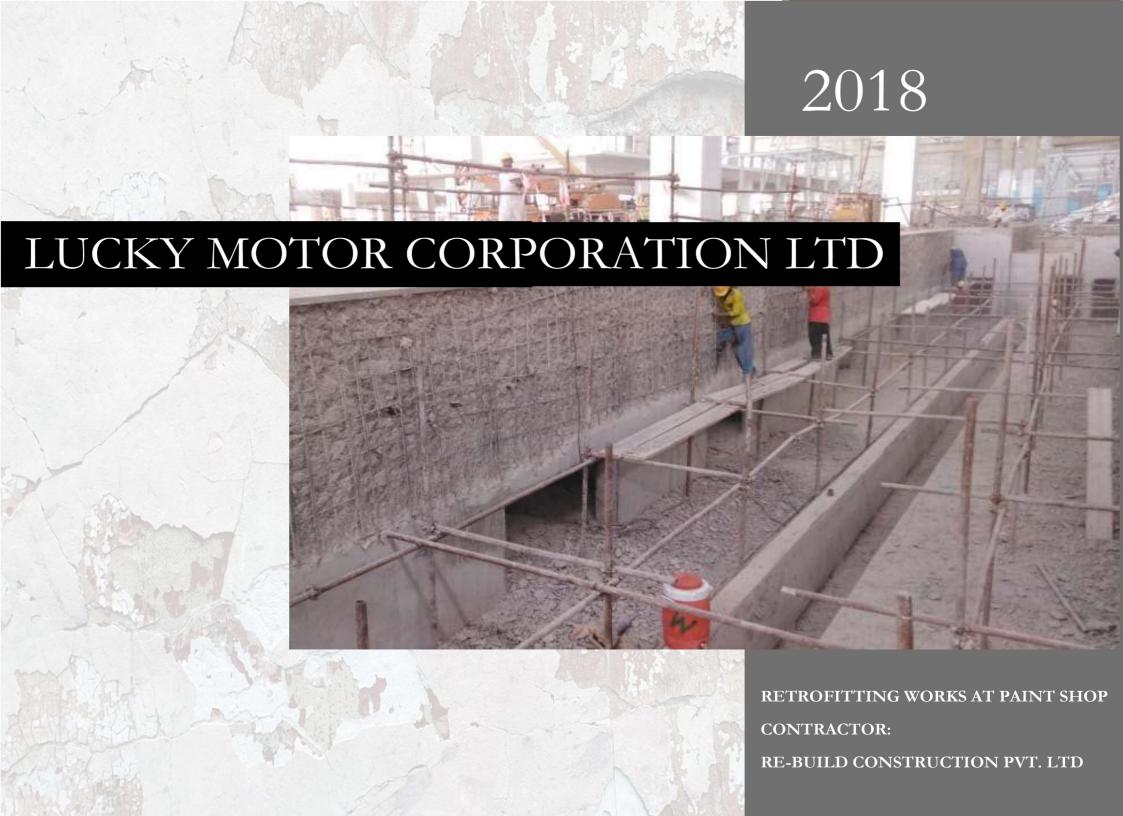
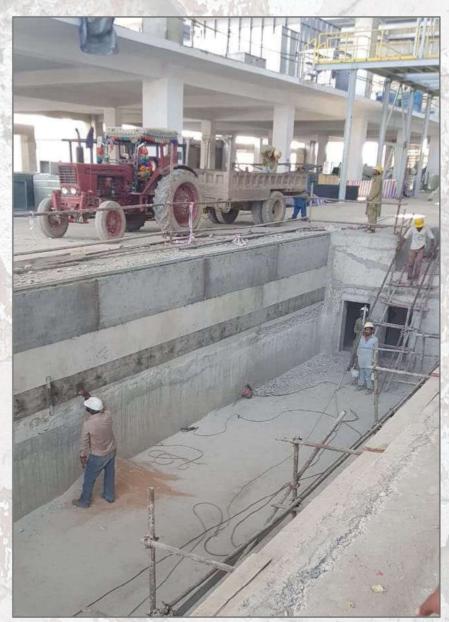
- Specialized Retrofitting was required at KIA Lucky Motors for two paint shops pits of 100m and 65m long.
- > These pit walls required internal distance of 5500mm but another contractor mistakenly constructed walls with lesser distance so we were approached for completing the task accurately.
- ➤ By using our retrofitting techniques we aligned walls and installed flushed SS Plates with countersunk mechanical anchors.
- Another requirement in the pit was regarding inclination slope of RCC Pit floor for proper flow of residual paint in Pit side by channel.
- We utilized our precise technique and experience, retrofit the walls and floor as per required slope in 100m and 65m length of floor.

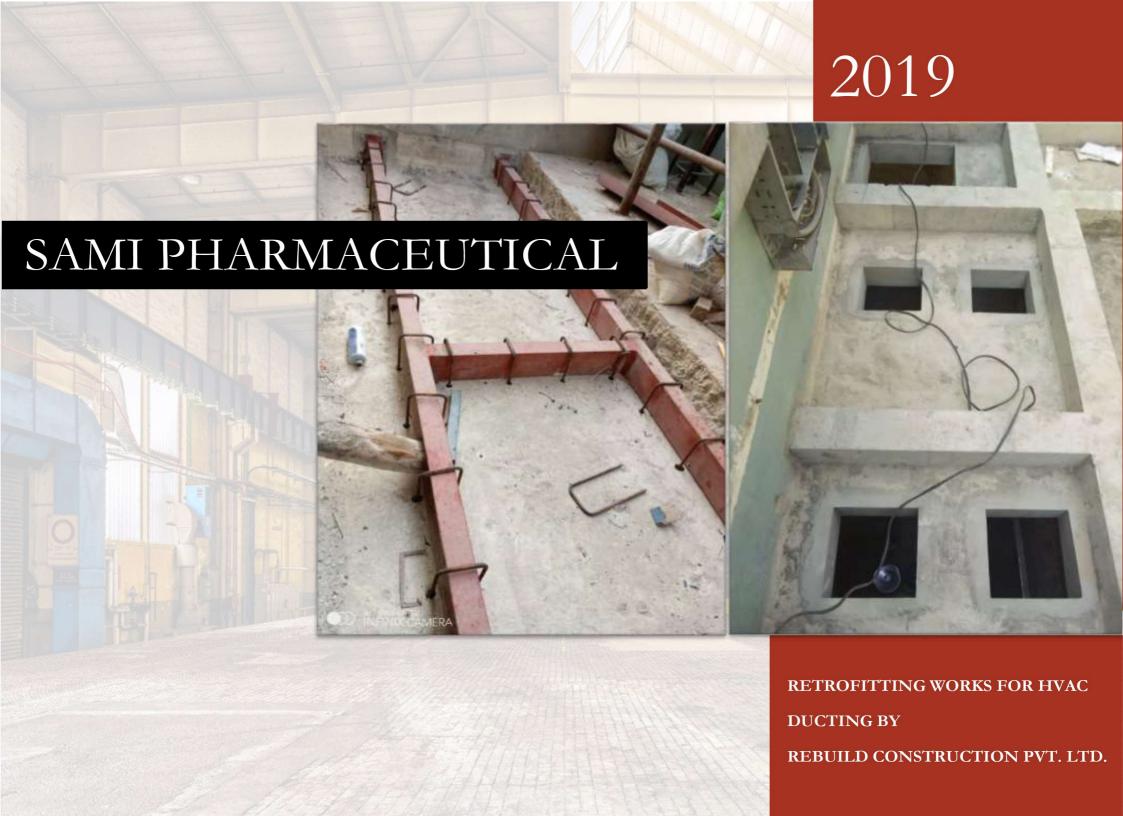
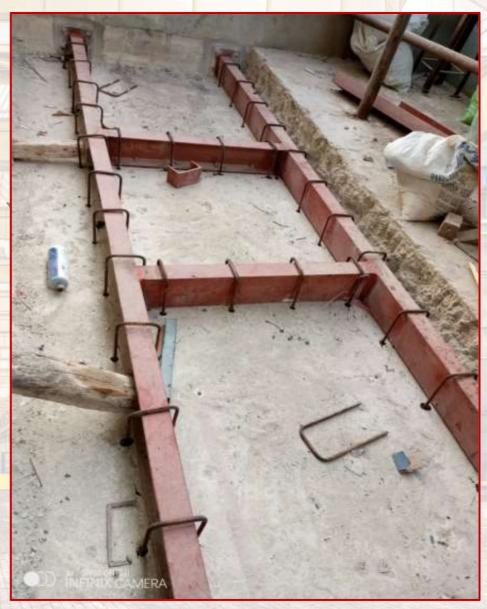
- ➤ Specialized Retrofitting was required due to HVAC duct openings to avoid cantilever action.
- ➤ Openings of 1'x1' and 2'x2' were made, Channels of 6"x3"x3/8"were installed using anchor bolts of 10mm which were embedded up to 90mm.
- MS Plates of 8"x8"x3/8" were welded with channels and fixed using bolts of 10mm.
- Utilizing our expertise of retrofitting shear connectors of 10mm were installed at 12" c/c distance.
- New RCC beam of compressive strength of 3000psi was placed.
- Using our technical knowledge of retrofitting the Client needs were fulfilled and task was done accurately.
- ➤ Work was executed with taking every safety precaution because safety comes first for us.

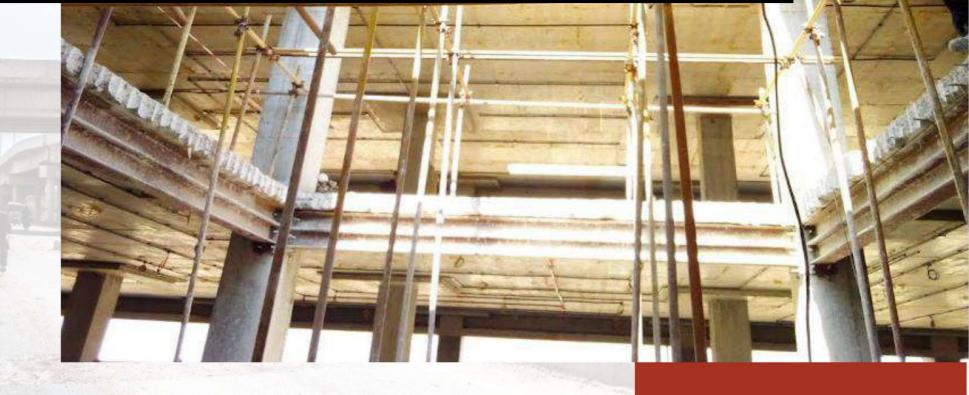
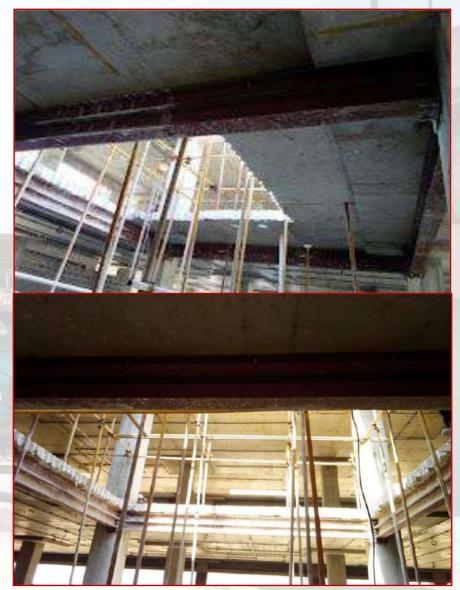
SLAB JACKETING

- ➤ Slab removal and jacketing work was required at KIA lucky motors.
- Drop panels were chiseled and fabrication of girders and plates was done.
- For Girders and plates were installed using Rawlplug® chemical anchors with Rawlplug® pure epoxy.
- For slab demolition, whole slab was vertically propped in grid pattern.
- > Through stitching cores pieces of slab were removed and later converted into debris.
- > Every challenge encountered was resolved by our experienced and qualified team utilizing experience of Retrofitting.

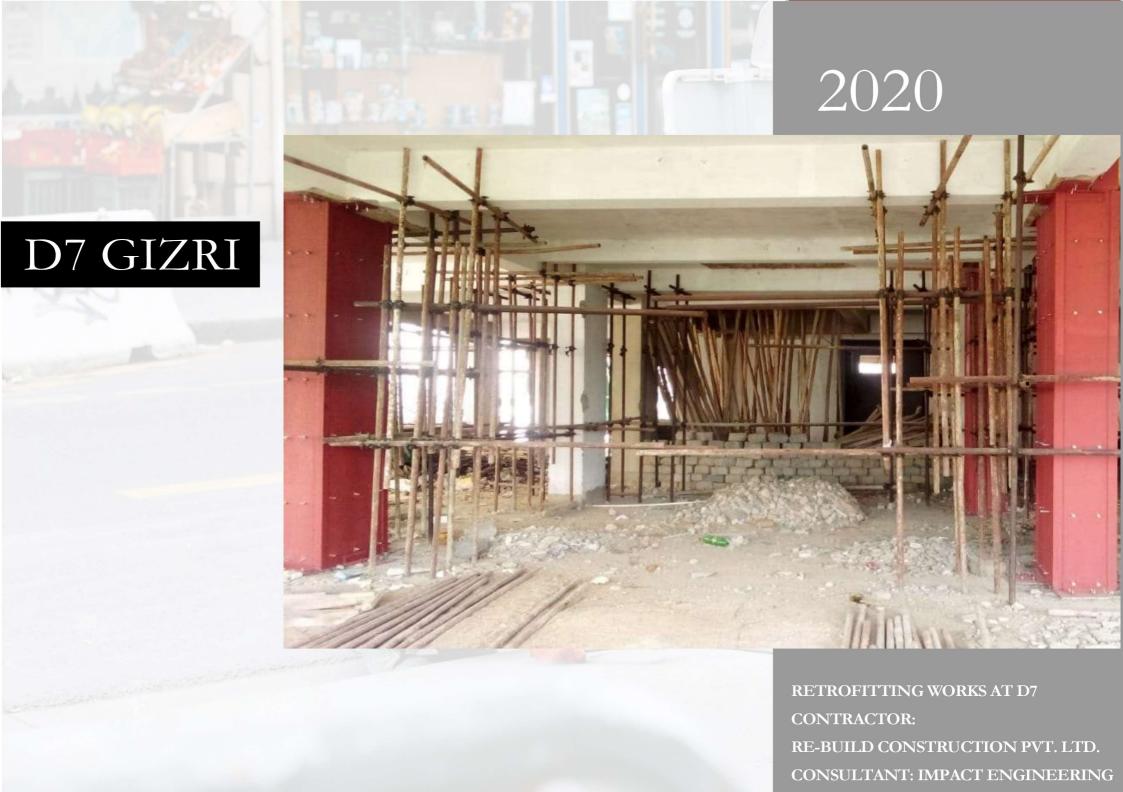
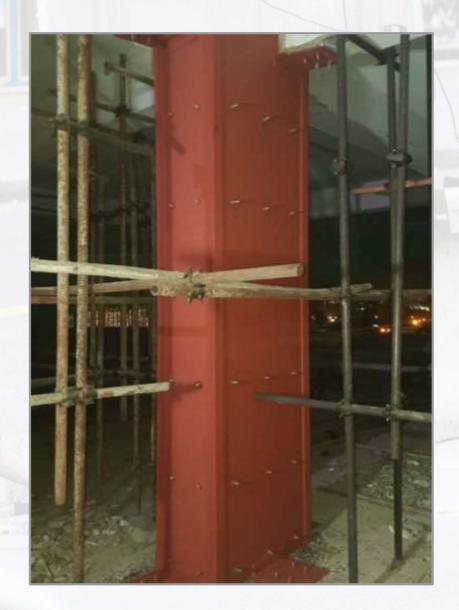
- ➤ Retrofitting by means of steel jacketing was required because the compressive strength for five columns at fifth floor were found less than required compressive strength.
- Ferro scanning was done along with preparation of as built drawings.
- ➤ MS Plates of 12mm thickness were fixed on column using Rawlplug® Stud anchors 16190-5.8 grade with high strength Rawlplug® RKEX-II Epoxy.
- > Over 500 anchors were installed.
- Corners of columns were welded via MS Angles. On top and bottom plates were fixed horizontally up to 2' by chemical anchoring and welded with vertical plate.
- > Using our retrofitting expertise, we were able to resolve every encountered challenge.

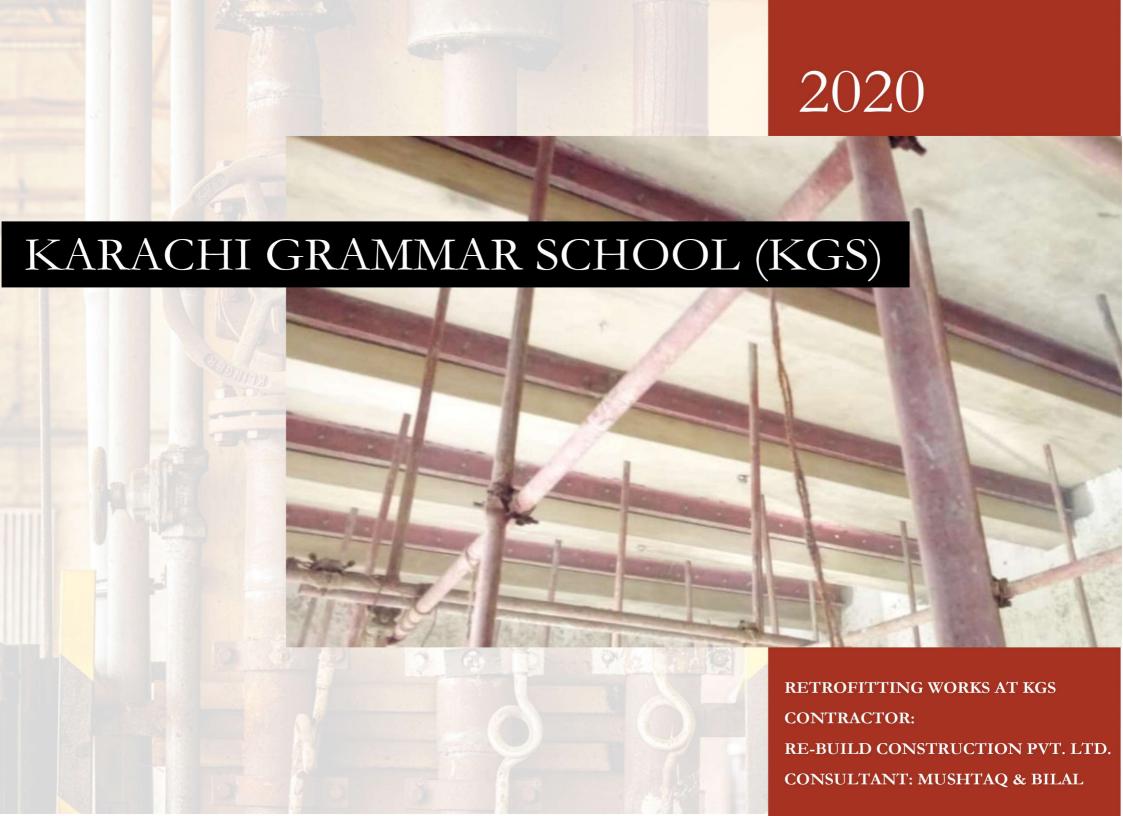
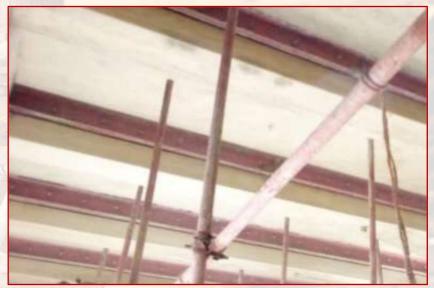
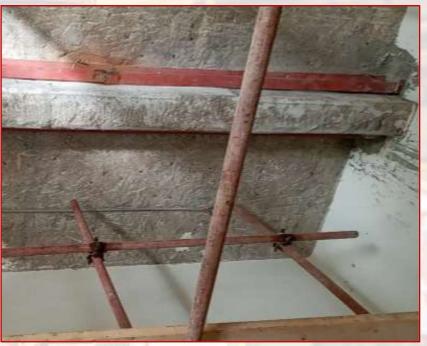
- ➤ Retrofitting was required due to extreme deterioration of beams so RBC presented the most efficient working plan.
- Chiseling of beam plaster and dismantling of wall portion was performed carefully.
- ➤ MS Channels were installed through Rawlplug® chemical anchors using Rawlplug® R-KEX-II Epoxy in drilled holes of dia 18mm up to depth of 5" on 12" c/c.
- ➤ MS plates of 6"x4"x3/8" were fixed.
- Concrete was laid properly then MS wire mesh was fixed on chiseled sections, 1" thick plaster was provided on slab and beams below installed MS Channels.
- Every complication encountered was overcome by using our technical knowledge of retrofitting.

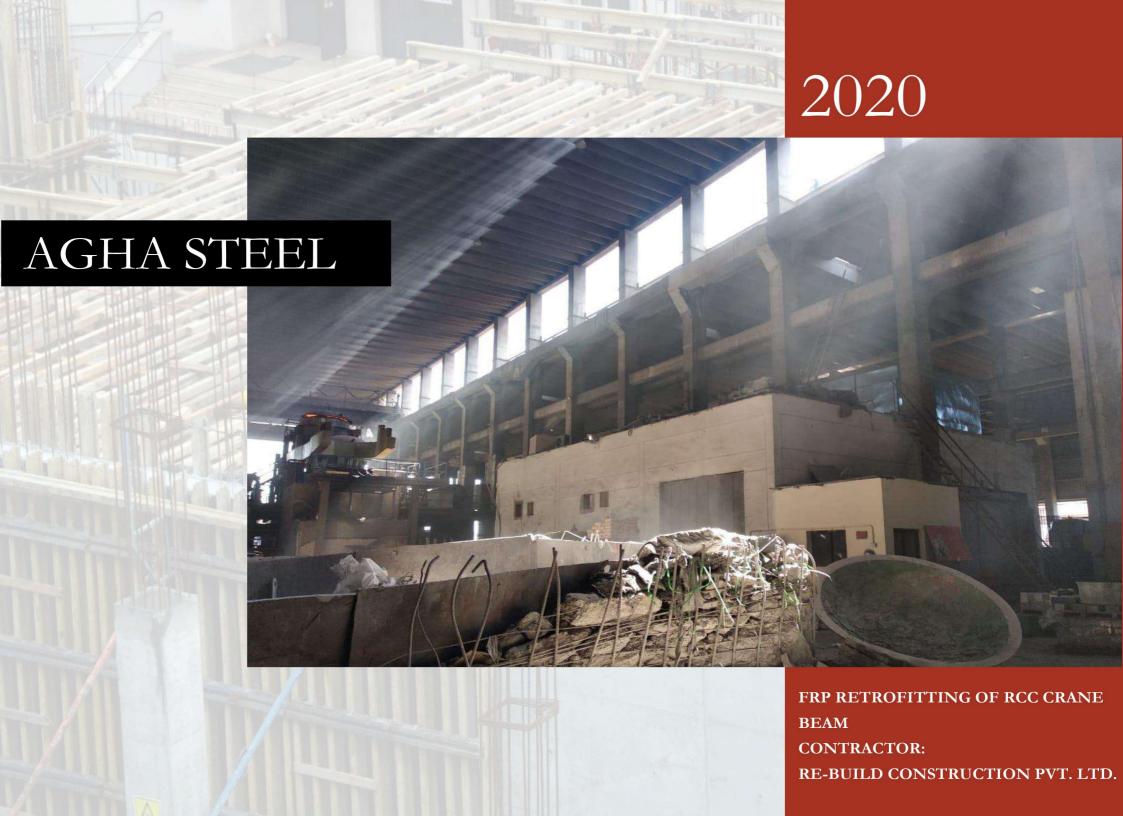
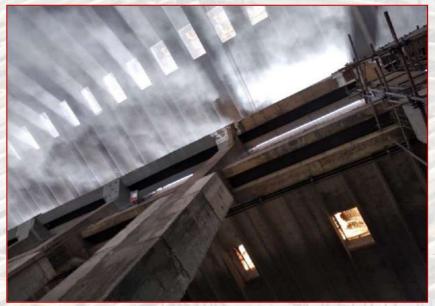
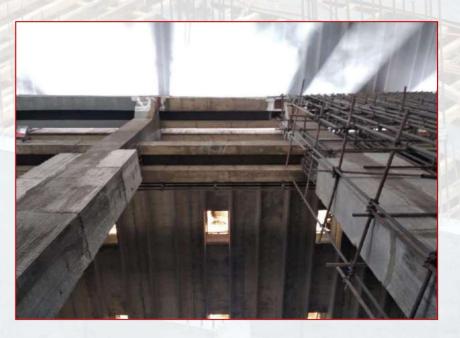
- > To cater the additional load on crane beams strengthening was required so strengthening through CFRP was proposed as the best solution for this problem.
- The new required crane capacity was 140 tons and 180 tons.
- Designing was done by Aegion Fyfe Asia Pte Ltd for TYFO® Fibrwrap® System using codes ACI 318M-05 and ACI 440.2R-17.
- For CR-BM1 one vertical layer of TYFO® Fibrwrap® Carbon System on both sides of the beam was suggested along with 10mm thick steel plate at bottom by means of anchors at particular spacing.

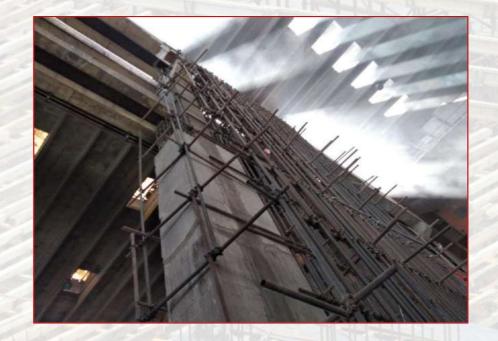
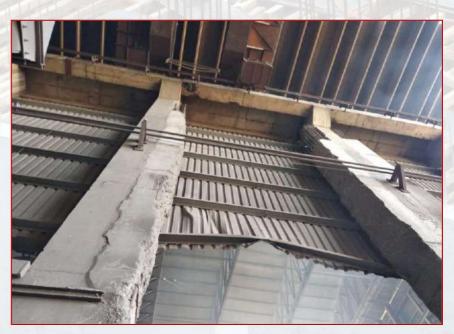
- For CR-BM2 two different types of TYFO® Fibrwrap® Carbon System were recommended, first for the U-wrap of one layer whereas two layers of sagging wrap to be provided.
- Crane girders were designed and checked accurately under shear, flexure and torsion.

Adequacy was section was checked.
- Columns were checked under loading and column analysis report was also provided.
- Software results and drawings were attached in technical report.
- Proper statement for the application of the Tyfo® Fibrwrap® Carbon systems was mentioned.

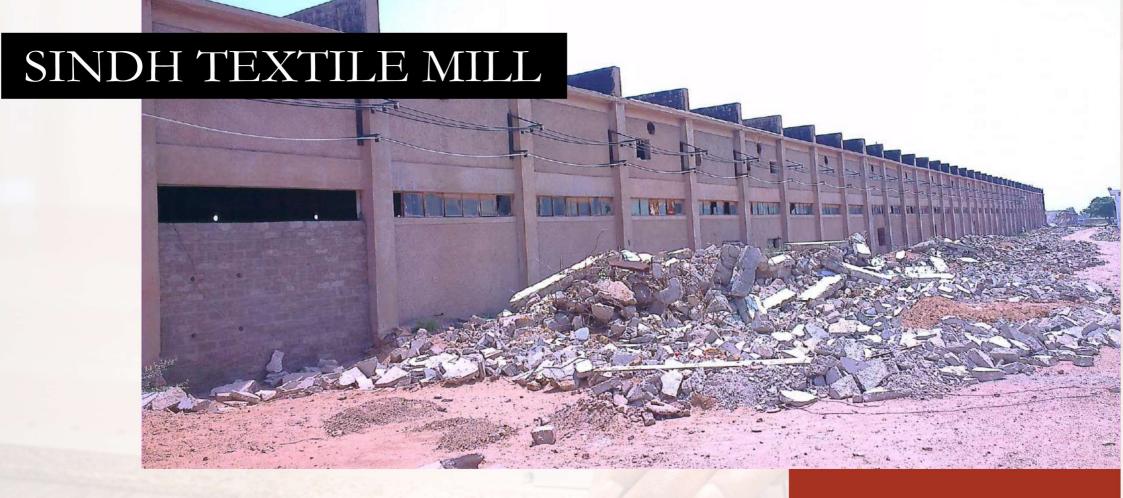
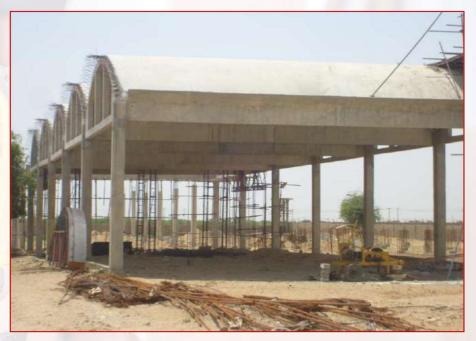
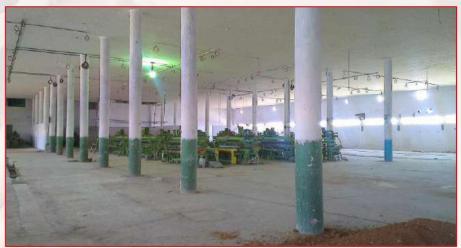
CFRP RETROFITTING FOR SEISMIC
STABILITY
CONTRACTOR:
RE-BUILD CONSTRUCTION PVT. LTD.

- The owner of the building intended to know about the structural stability of the building for future Seismic Activity and Wind loads.
- After performing structural testing it was concluded that building needs retrofitting because there were no Plinth beams and SOG.
- he slab thickness used in the building is too thin i.e. inadequate for such span and therefore as expected cracks were visible in the slab.
- > Structure was found vulnerable in case of future seismic activity.

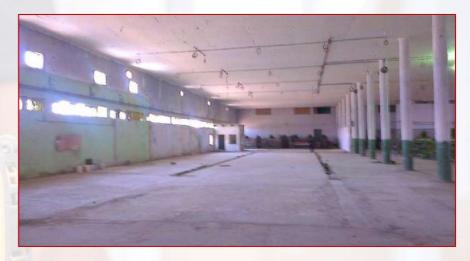
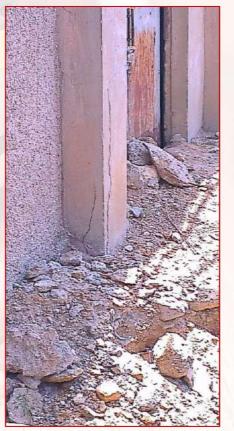
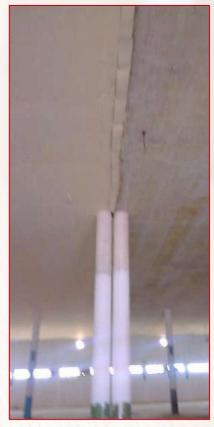
- FRP Retrofitting was suggested for beams and columns as the most economical and efficient solution since it was demanded that operations won't be stopped even during retrofitting works.
- Designing was done by Aegion Fyfe Asia Pte Ltd for TYFO® Fibrwrap® System using codes ACI 318M-05 and ACI 440.2R-17.
- ➤ CFRP vertical wraps for columns and for inverted beams to control hogging were elaborated in drawings.
- > Proper statement for the application of the Tyfo® Fibrwrap® Carbon systems was shared.

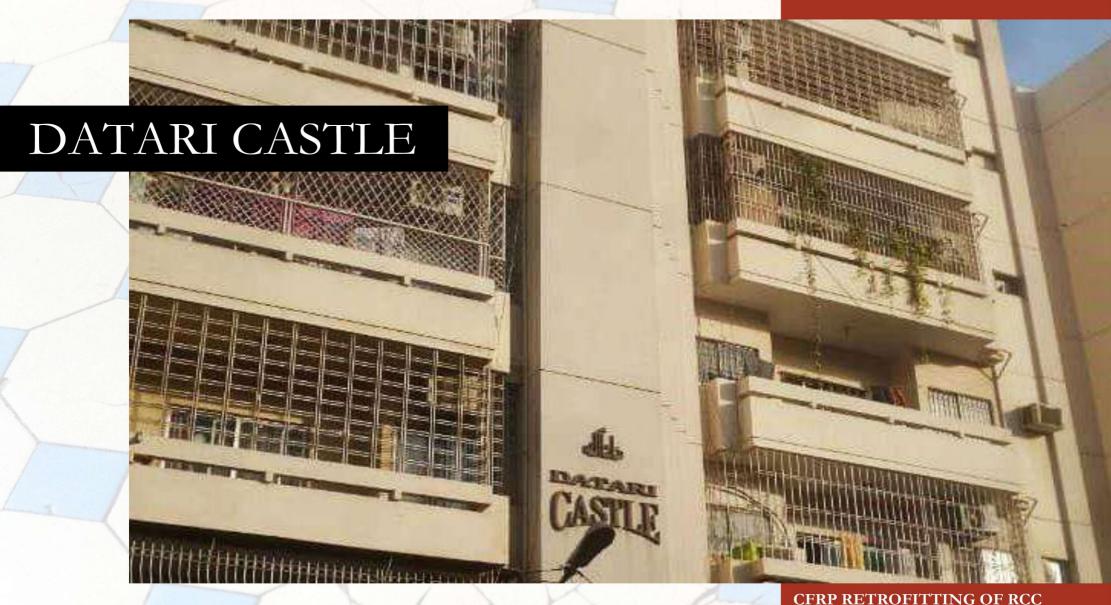
**COLUMN**

- ➤ InDatari's castle few columns of Ground floor were deteriorated due to rainwater so RBC was approached for solution.
- Column strengthening through CFRP was proposed as the best solution.
- ➤ Designing was done by Aegion Fyfe Asia Pte Ltd for TYFO® Fibrwrap® System using codes ACI M318-05 and ACI 440.2R.
- > PM interaction analysis were performed.
- First it was recommended to repair the deteriorated portion of column.
- ➤ It was suggested in design proposal to wrap CFRP horizontally and vertically extending 200mm above the deteriorated surface of

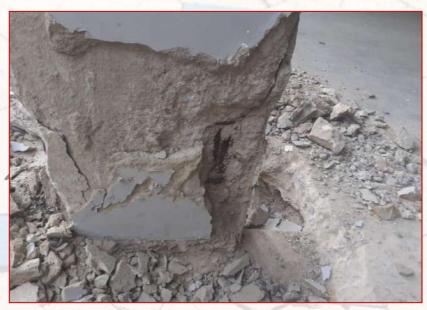
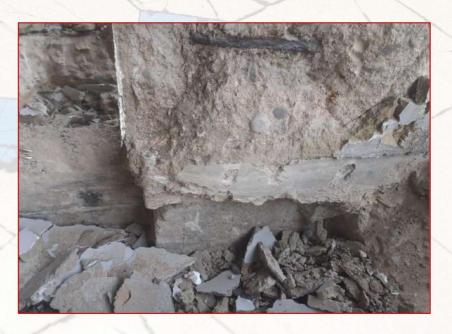
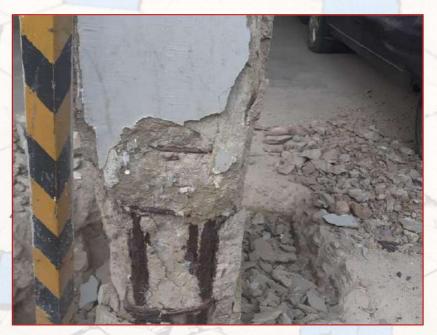
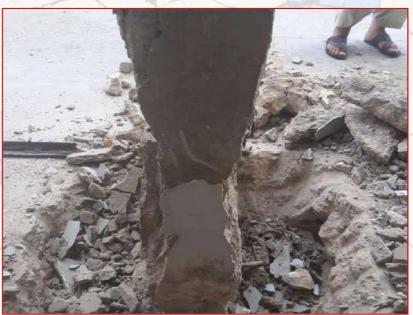
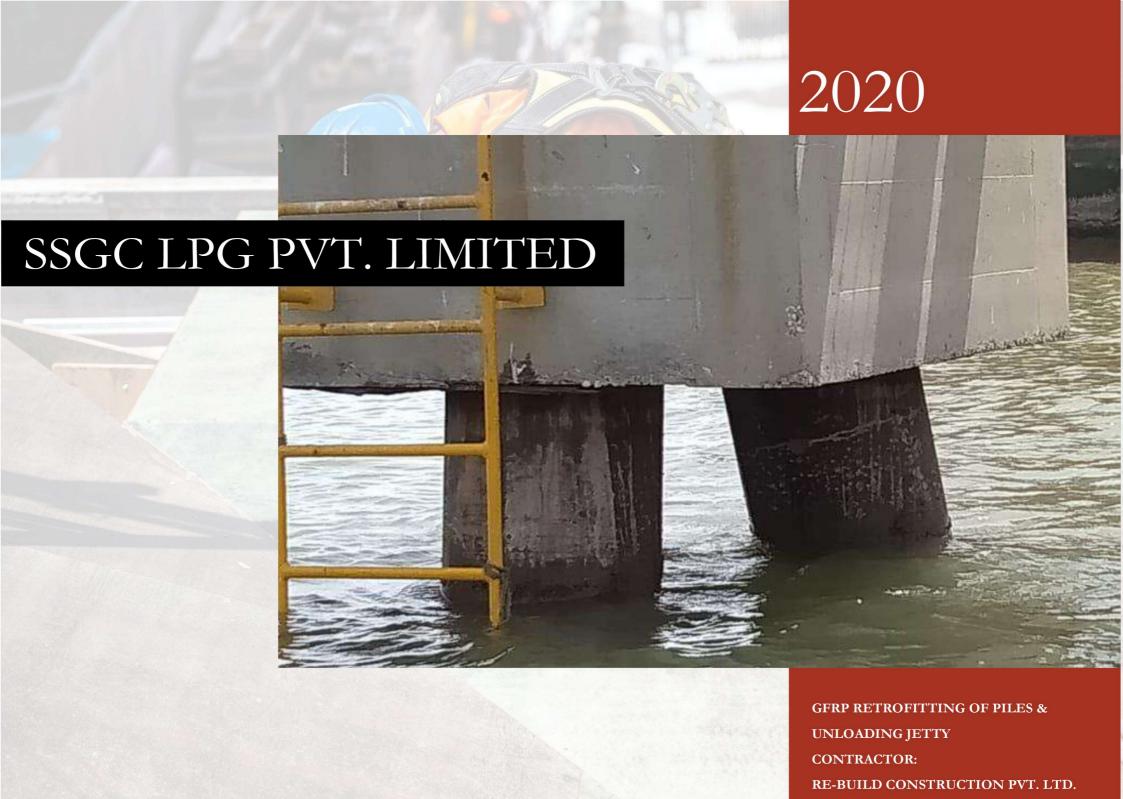
- column with one layer of Tyfo® Fibrwrap® Carbon System.
- > Proper lap length for horizontal layer was mentioned.
- ➤ By CFRP strength was increased up to 15.25 N/mm² from 11.72 N/mm² with just one layer (horizontal & vertical) following confined concrete model.
- ➤ Method statement for the application of the Tyfo® Fibrwrap® Carbon Systems was attached.
- Project briefs of similar cases were attached in technical proposal.

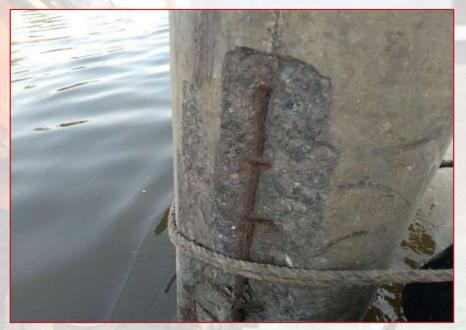
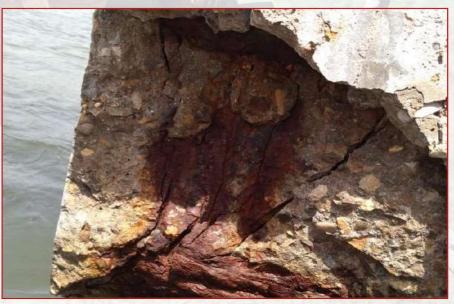
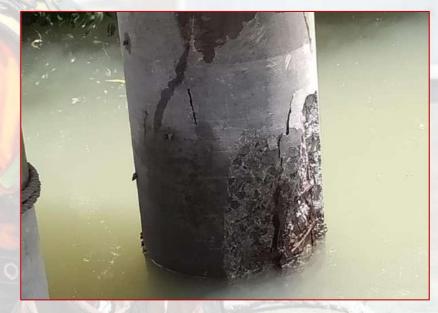
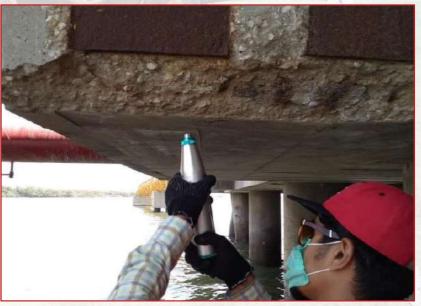
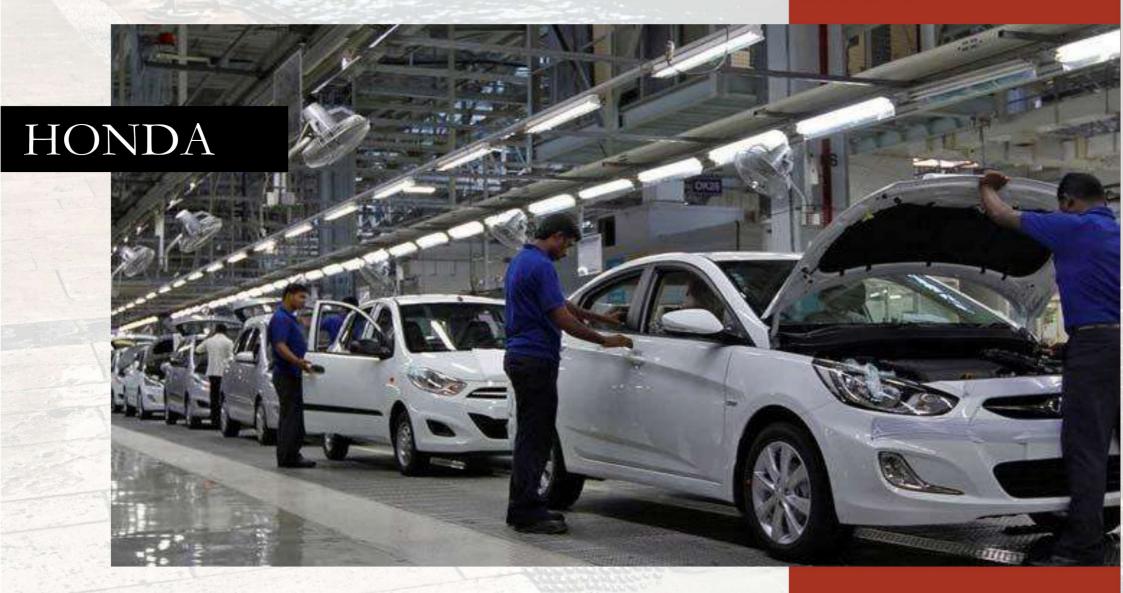
- ➤ Rehabilitation of splash zone of Hollow core reinforced concrete Jetty piles was required due to spalling of concrete and corrosion of rebars.
- The Tyfo® Fibrwrap® System (GFRP) was suggested to use to prevent further corrosion while compensating for loss of tensile force due to corroded rebars.
- Designing was done by Aegion Fyfe Asia Pte Ltd for TYFO® Fibrwrap® System using code ACI 440.2R-17.
- ➤ Designing was based on two assumptions: 1. 60% main (vertical) rebar area is lost due to corrosion.

- 2. 100% of spiral rebar area is lost due to corrosion.
- ➤ It was recommended to install one layer of Tyfo® Fibrwrap® System in vertical direction.
- For horizontal direction two layers of Tyfo® Fibrwrap® System were to be installed.
- Earlier there was no cathodic protection on structure so Tyfo® Fibrwrap® System was provided as a corrosion protection layer.
- Method statement for the application of the Tyfo® Fibrwrap® systems for Piles was attached with pictorial description of application method for proper guidance.
- > Similar completed international projects' reports were also attached.

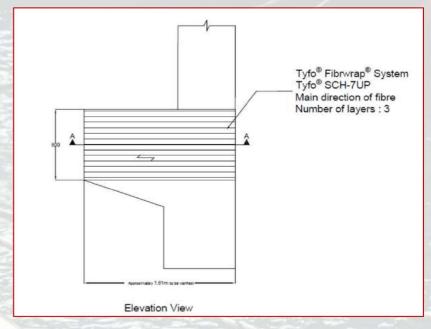
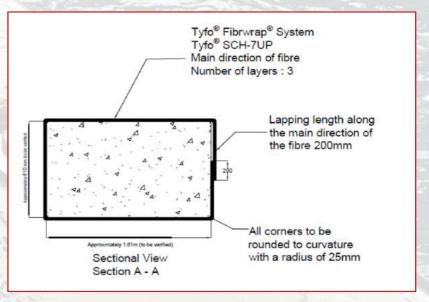
CFRP RETROFITTING AT HONDA
CONTRACTOR:
RE-BUILD CONSTRUCTION PVT. LTD.

- Corbel strengthening was required due to missing steel links so RBC was approached for solution.
- Corbel strengthening through CFRP was proposed as the best solution for this problem.
- Designing was done by Aegion Fyfe Asia Pte Ltd for TYFO® Fibrwrap® System.
- ➤ It was suggested in design proposal to wrap the entire surface of cross-sectional area of missing links with three layers of Tyfo® Fibrwrap® Carbon System.
- > Proper method statement for the application of the Tyfo® Fibrwrap® Carbon Systems was attached.

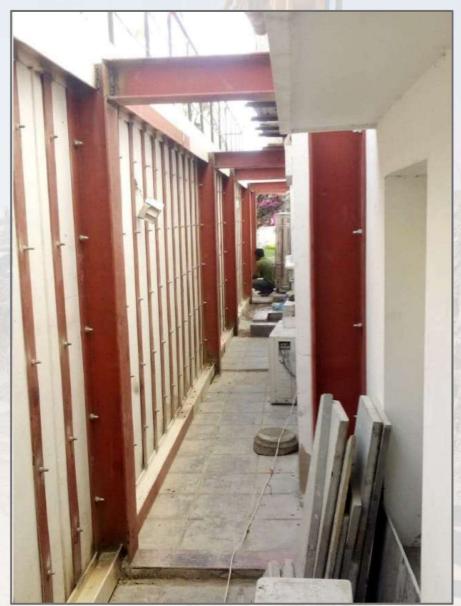
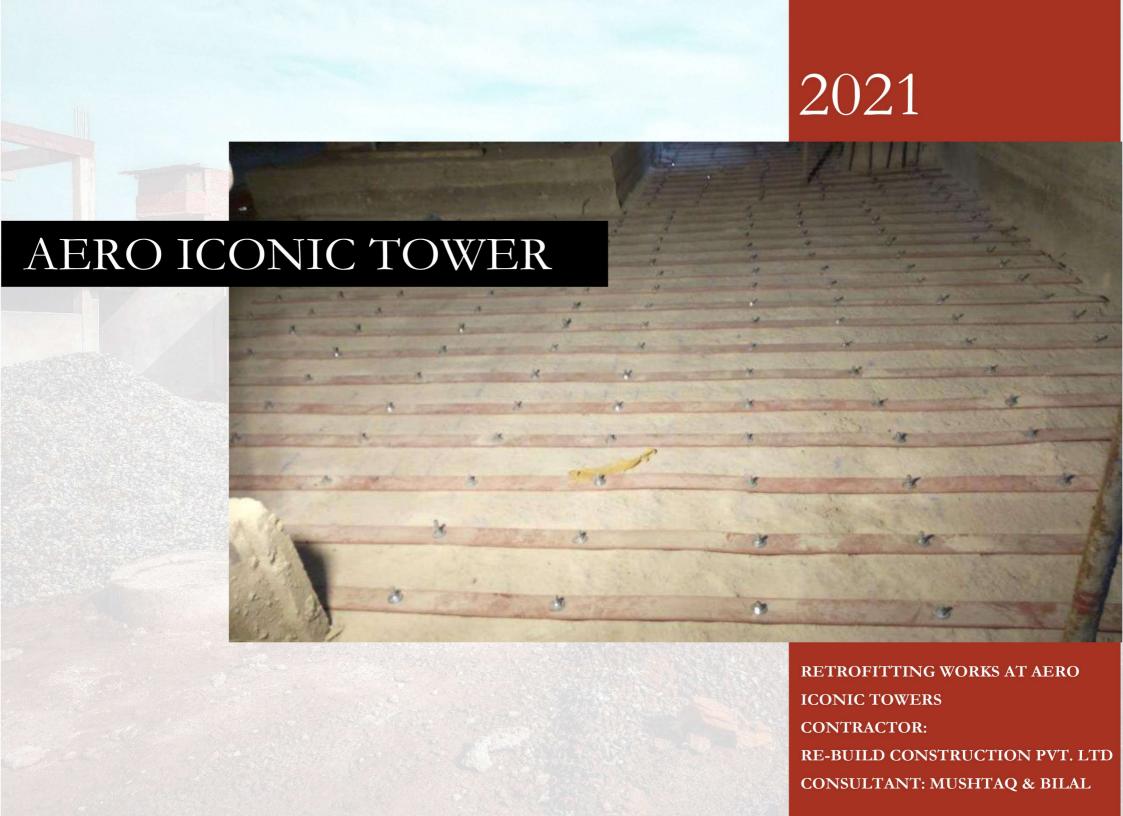
- ➤ Specialized Retrofitting was required because boundary wall which was resisting soil at the back face, due to excessive load large cracks appeared which made wall incapable of bearing more load.
- ➤ MS Plates of 3" width with thickness of 1/4" at 12" c/c distance to be installed by means of anchors.
- ➤ Installation of ten Columns of W-Section 6"x6" and 8"X8" along with beams of WSection 6"x6" and 4"x4", bolting of anchors and welding of frame was done appropriately.
- ➤ Utilizing our expertise of retrofitting, activity was done accurately and client was satisfied.
- Work was executed with following all safety precautions because safety is our priority.

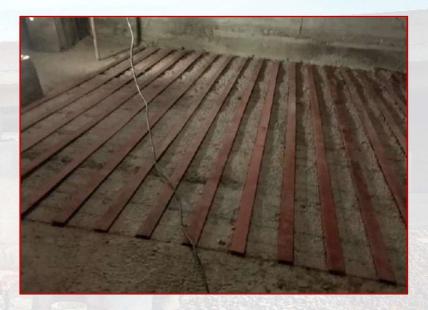
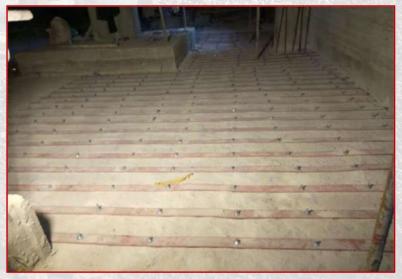
- At Aero Iconic Tower Shear Strengthening of Raft foundation was required so RBC presented the most efficient work plan
- ➤ Before drilling holes Ferro scanning was done along with preparation of as-built drawings for installation of anchors.
- After drilling on raft, MS Plates were fabricated and installed using Rawlplug® Mechanical anchors.
- Rawlplug® Mechanical anchors were torqued properly.
- For concrete jacketing of columns rebar doweling was also done using the Rawlplug® Pure Epoxy.
- > All the work was executed efficiently, adhering to safety precautions.

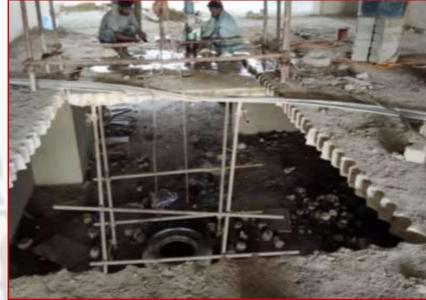
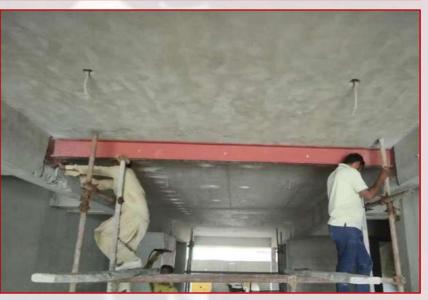
RETROFITTING ALZOHRA TOWER

- > Slab removal and jacketing work was required at Al-Zohra Tower to make opening for staircase and to transfer its load.
- > MS Channels and MS plates were fabricated.
- After chiseling beam for plates, holes were drilled for anchors in order to fix plates.
- > Plates were fixed using Rawlplug® chemical anchors.
- Finally all Channels were fixed and welded.
- Slab was demolished in pieces using anti-vibration tool.
- Removed slab piece was shifted downward using chain pulley arrangement.
- Each piece was divided into small pieces to make debris.
- > The whole task was completed timely and efficiently.
