RETROFITTING & RENOVATION
WORKS AT HOUSE OF HABIB
CONTRACTOR:

RE-BUILD CONSTRUCTION PVT. LTD

## UNILEVER HEAD OFFICE, AVARI TOWERS

RETROFITTING WORKS AT
UNILEVER HEAD OFFICE
CONTRACTOR:
RE-BUILD CONSTRUCTION PVT. LTD
CONSULTANT: MUSHTAQ & BILAL

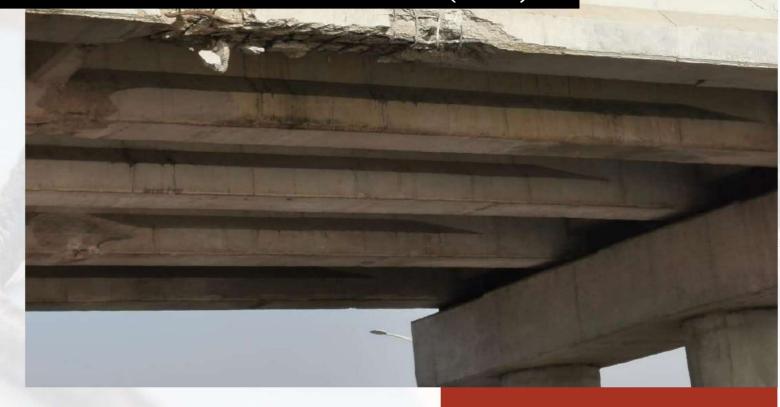
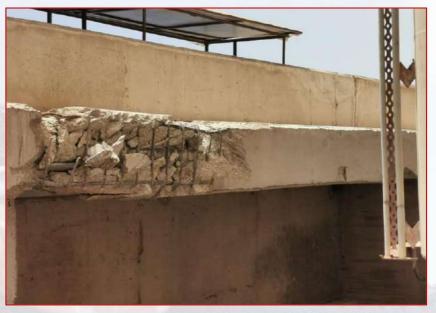
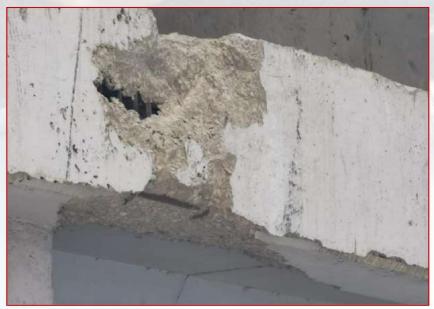
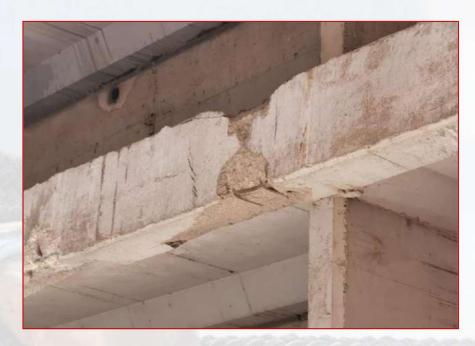
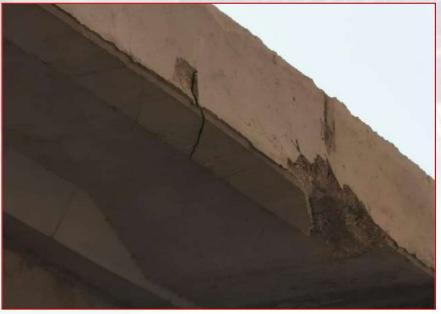
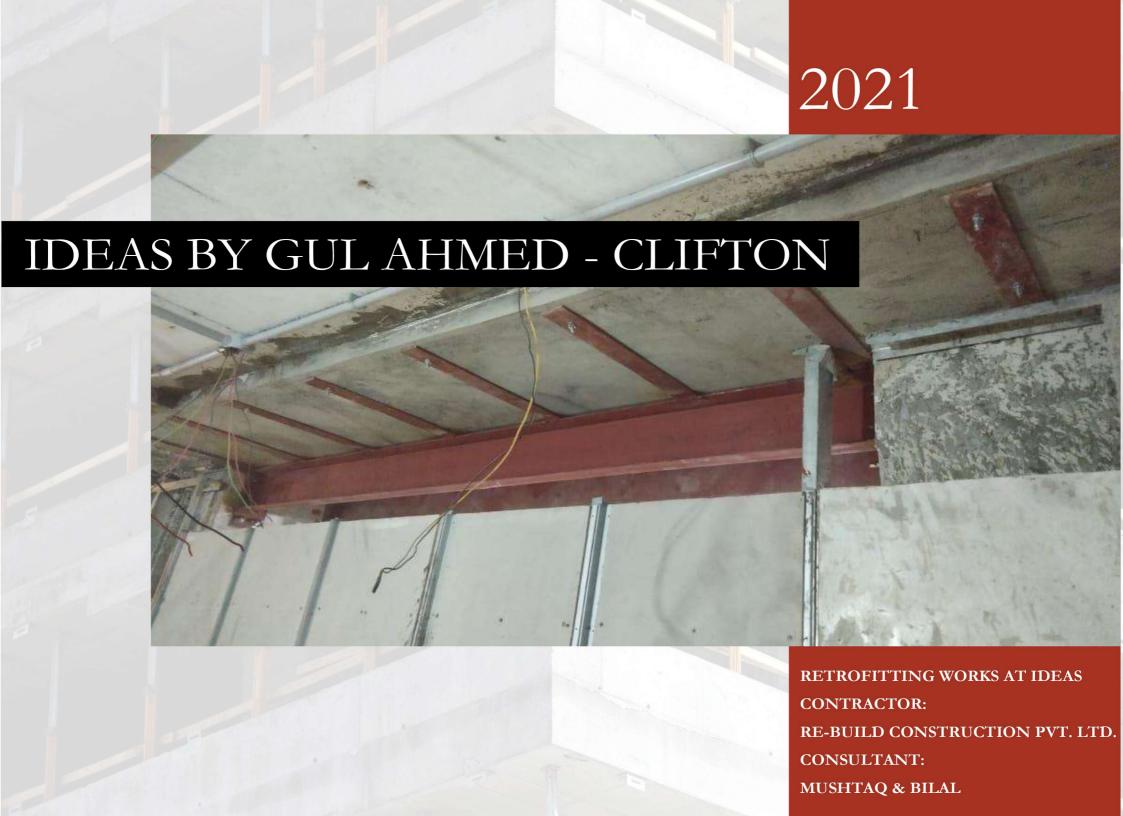
# EDHI VILLAGE INTERCHANGE (M9)

- Due to the vehicular impact PC Girders were damaged and strengthening was required.
- > Girder strengthening through CFRP was proposed as the best solution for this problem.
- Designing was done by Aegion Fyfe Asia Pte Ltd for TYFO® Fibrwrap® System using codes ACI 318M-05 and ACI 440.2R-17.
- ➤ Five members of PC Girders were affected by the vehicular impact.
- ➤ One Girder (PCG1) was severely damaged whereas remaining four Girders (PCG2) were minimally damaged.

- ➤ In PCG1 10% of yield stress of tendons was lost and two bottom rebars and three stirrups were damaged.
- ➤ In PCG2 two rebars and one stirrup was damaged but tendons remained unaffected and intact.
- ➤ It was suggested in design proposal for Moment strengthening to use five layers of CFRP for PCG1 and two layers for PCG2.
- ➤ In case of Shear strengthening two layers of CFRP in PCG1 and one layer in PCG2 was suggested.
- ➤ Proper statement for the application of the Tyfo® Fibrwrap® Carbon systems on dry surfaces was mentioned.

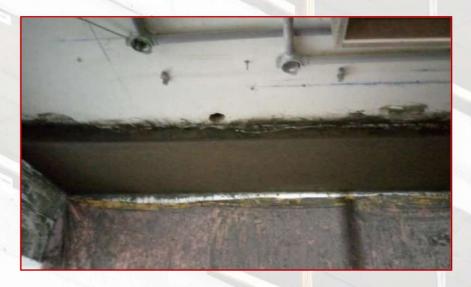
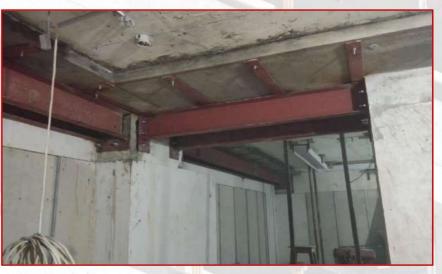
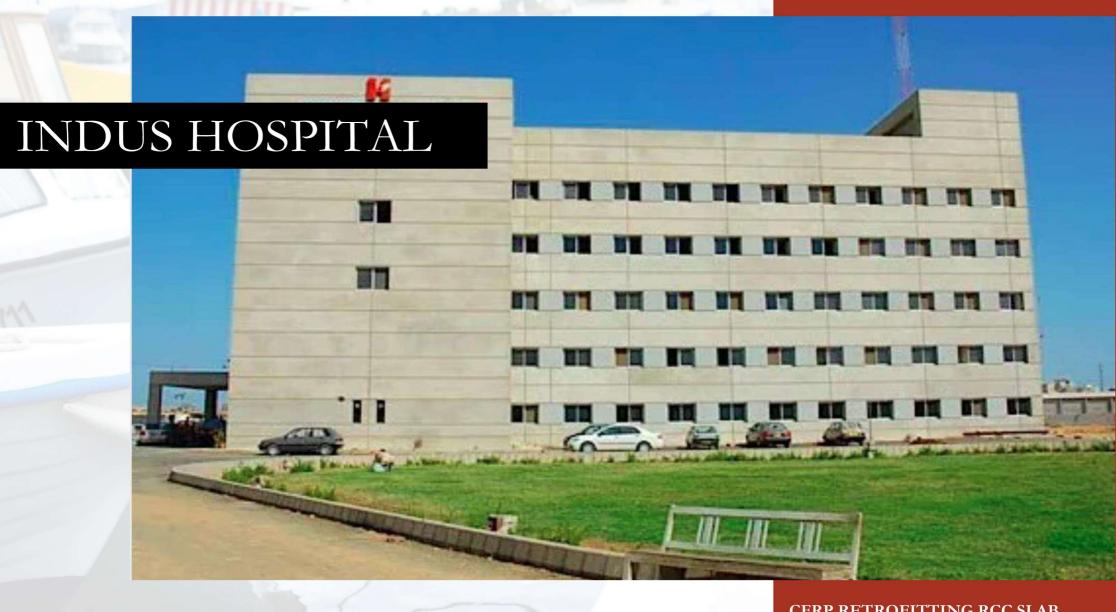
- At Ideas the concrete started to spall off due to seepage and reinforcement was corroded so RBC was approached for specialized retrofitting.
- Anti-corrosive epoxy was coated on exposed reinforcement after replacement of damaged plaster with strengthening plaster made of different admixtures and hardener.
- ➤ MS Plates were installed at particular center to center spacing using Rawlplug® chemical anchors with Rawlplug® R-KEX-II Epoxy on drop panels.
- MS Channels were installed through Rawlplug® chemical anchors using Rawlplug® R-KEX-II Epoxy.
- > Every hindrance was overcome by using our technical knowledge of retrofitting.

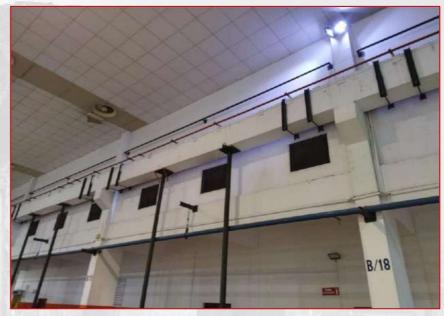
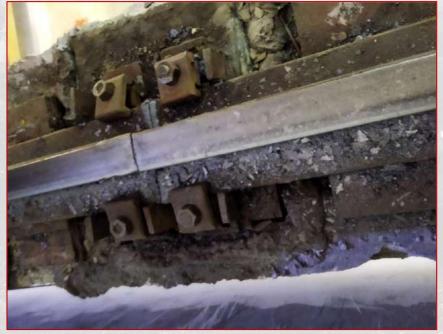
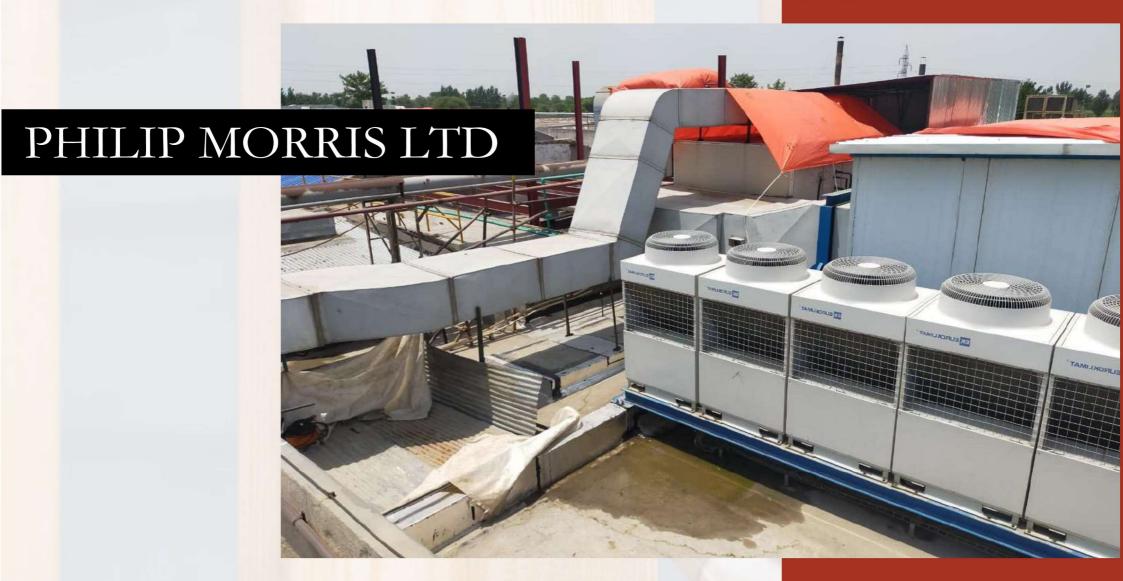
BEAM
CONTRACTOR:
RE-BUILD CONSTRUCTION PVT. LTD.

- > To cater for the shortfall in design capacity causing cracks in some of the crane beams strengthening was required so CFRP was proposed as the best solution for this problem.
- ➤ Designing was done by Aegion Fyfe Asia Pte Ltd for TYFO® Fibrwrap® System using codes ACI 318M-05 and ACI 440.2R-17. Different load scenarios were considered in Analysis.
- ➤ One layer of TYFO® Fibrwrap® Carbon System as U-wrap in whole span to be provided.
- ➤ Proper statement for the application of the Tyfo<sup>®</sup> Fibrwrap<sup>®</sup> Carbon systems was mentioned.

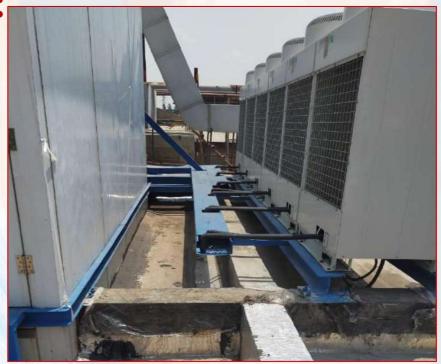
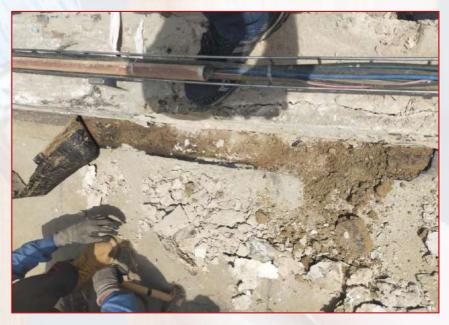
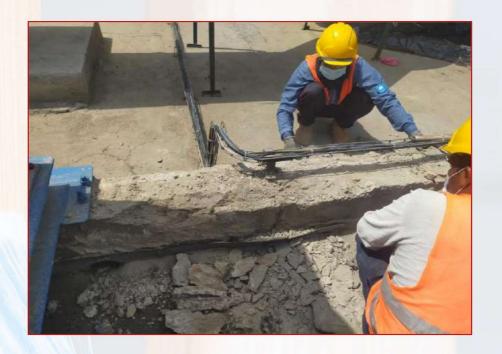
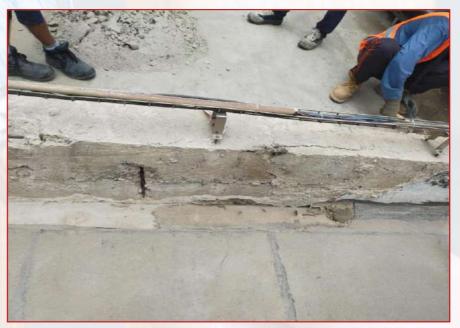
FRP RETROFITTING OF ROOF SLAB CONTRACTOR: RE-BUILD CONSTRUCTION PVT. LTD.

- The beams were to be strengthened due to the reduction area of the steel reinforcement caused by corrosion so Tyfo® Fibrwrap® Systems was proposed to strengthen beams and slabs to achieve their original capacity before corrosion.
- ➤ Designing was done by Aegion Fyfe Asia Pte Ltd for TYFO® Fibrwrap® System using codes ACI 318M-05 and ACI 440.2R-17.
- The loss in area of the reinforcement is taken as 10% reduction in the diameter of the steel reinforcement.
- ➤ One layer of particular width of TYFO®
  Fibrwrap® Carbon System to be applied in

- x-axis and y-axis on Slab at specified center to center spacing.
- ➤ One layer of TYFO® Fibrwrap® Carbon System to be installed on beams for controlling hogging, sagging & shear at particular length & spacing.
- > Technical datasheet of products was provided.
- Software results and drawings were attached in technical report.
- Proper statement for the application of the Tyfo® Fibrwrap® Carbon systems on structural members was mentioned.

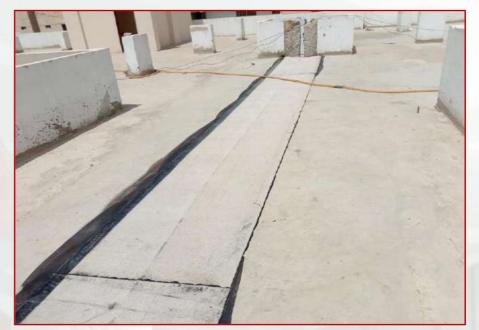
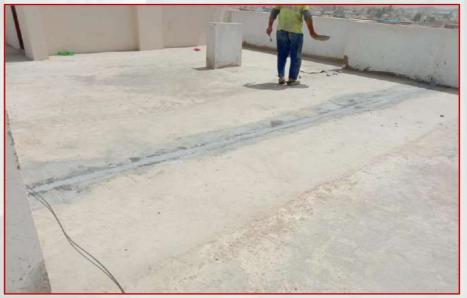
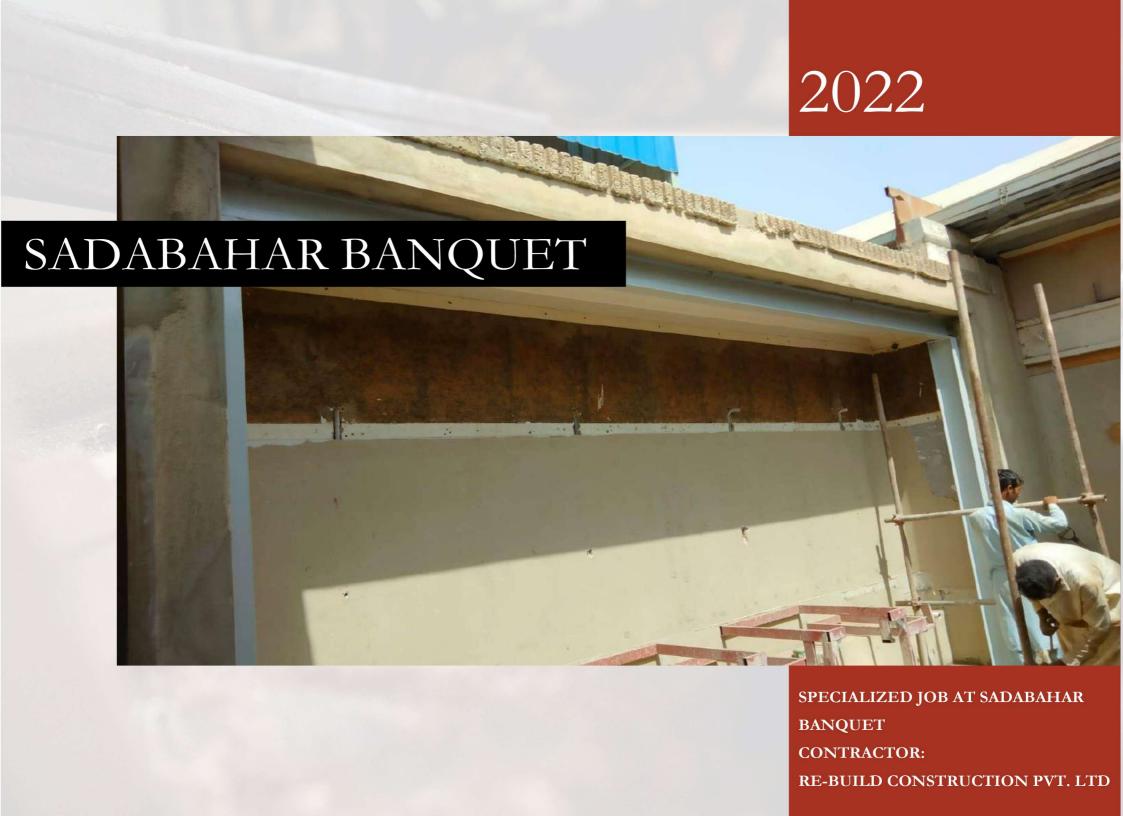
- At Kings Cottage it was required to do waterproofing of very large and irregular expansion joint so RBC was approached to perform this task.
- ➤ After removing screed, backer rod was inserted in expansion joint which is soft and pliable filler designed to partially fill concrete expansion joints.
- ➤ Polysulphide sealant was used to caulk backer rod and chemically resist water penetration.
- ➤ Then Plastogrip which is water proofing membrane was applied through torching.
- ➤ The waterproofing work was done following standard procedures by utilizing our expertise.
- ➤ Rebuild Construction is making all efforts to protect existing structures and to meet client's requirements.

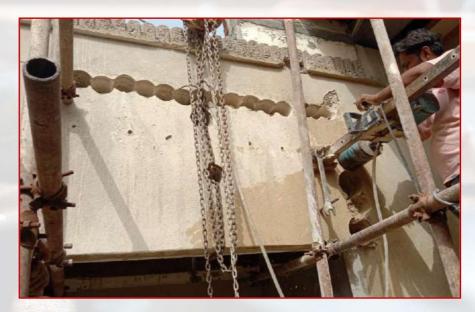
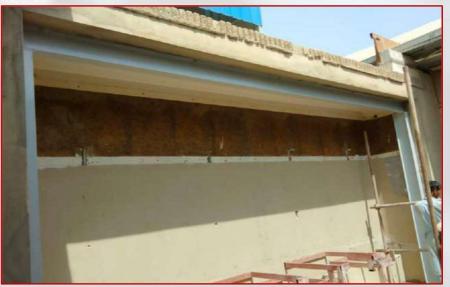
- ➤ At Sadabahar Banquet it was required to demolish RCC Pardi Beam to extend office so RBC was approached to execute work.
- Removal of RCC Pardi was done in pieces via anti vibration tool through stitch coring.
- > Foundations for two MS Columns were laid.
- ➤ Fabrication of MS Columns and MS Girders of W4x8 was done.
- ➤ MS Columns were inserted and erection of MS Girder was done beneath the cutting edge of RCC Pardi Beam.
- Columns and Girder was painted with Red oxide paint.
- ➤ All the work was executed with efficiency & proficiency within specified short deadline, adhering to safety precautions.
